Manhole Inspection Summary

Manhole # S19C__016MH

Insp Date: **10/15/07 11:18 AM**

Location Address: **2101 MULBERRY ST**

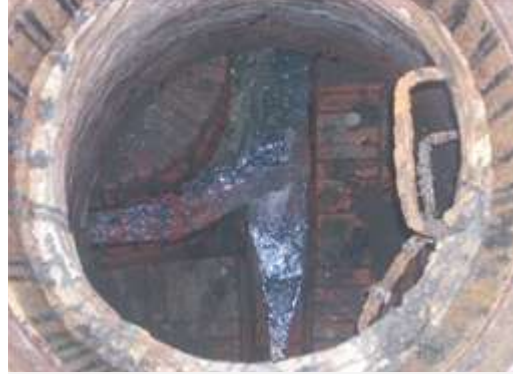
Top View

Comments **frame looks broken**

Condition: ☐ Sound ☒ **Cracked** ☐ Leaks

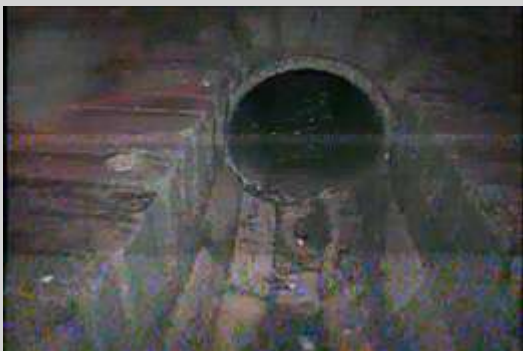
6 O'Clock Inflow

8 in. Circular Gravity Sewer
Pipe In @ 6 O'Clock

Pipe Height: **8.4** (in.) Rod and Bar (Angled)
Pipe Material: **Clay** ☐ Pipe Lined
Invert Depth: **7.69** (ft.) Flow Characteristics: **Slow**
Deposits: ☒ **None** ☐ Mud ☐ Sludge ☐ Debris ☐ Grease
Silt Depth: (in.) Deposits Extent:
Infiltration: **None** Pipe Seal Cond: **Sound**

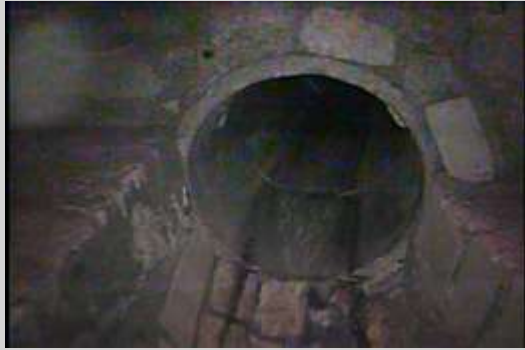
9 O'Clock Inflow

10 in. Circular Gravity Sewer
Pipe In @ 9 O'Clock

Pipe Height: **9.6** (in.) Rod and Bar (Angled)

Infiltration: **None** Pipe Seal Cond: **Sound**
